# DAMAGE ASSESSMENT FORM

Building Name PALM LODGE

Address 17390 SW 296 STREET

Date of Construction ca. 1912 Folio No. 30-7907-000-0110

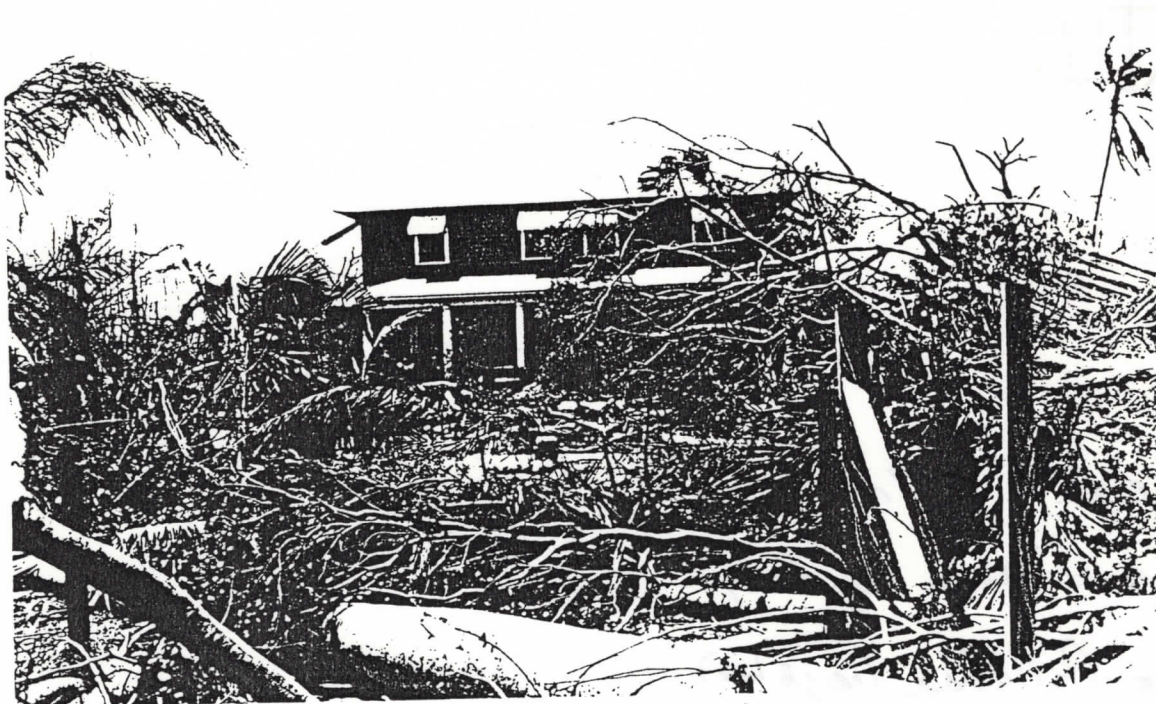
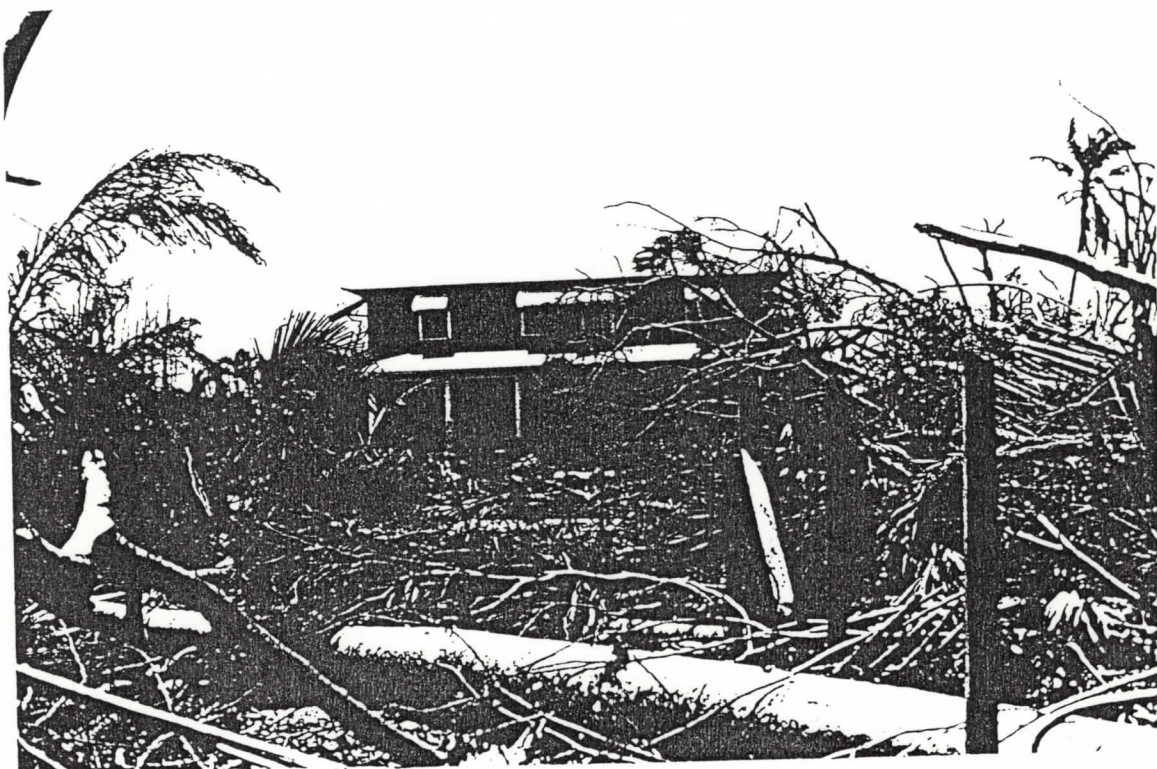
PALM LODGE

%	Comments
Exterior Walls	<u>1</u>	
Frame (General Condition)	<u>20</u>	
Frame Members	<u>20</u>	<u>&amp; 2nd Floor damage from chimney</u>
Frame Connections	<u>10</u>	<u>falling through roof</u>
Roof Framing	<u>20</u>	<u>eaves, rafters in 20%</u>
Roof Covering	<u>20</u>	<u>new tin in some places</u>
Foundation	<u>0</u>	
Chimney(s)	<u>50</u>	<u>Fell into House</u>
Doors	<u>10</u>	<u>mostly broken glass</u>
Windows and Shutters	<u>10</u>	
Porch	<u>0</u>	
Downspouts and Gutters	<u>NA</u>	
Interior Bearing/Shear Walls	<u>0</u>	
Partitions (Nonbearing)	<u>1</u>	<u>water damage</u>
Floor(s)	<u>1</u>	
Stair(s)	<u>0</u>	
Glass	<u>20</u>	
Mechanical Equipment	<u>NA</u>	
Electrical Equipment	<u>NA</u>	
Garden and Trees	<u>50</u>	
Fences and Garden Walls	<u>40</u>	
Walkways and Sidewalks	<u>20</u>	
Other: _____		
Total Damage	<u>20</u>

OWNER IS WORRIED THEY WON'T BE ABLE TO AFFORD TO REPLACE THE TIN SHINGLES

Recommendations for Immediate Actions MOST NECESSARY ACTION HAS BEEN TAKEN - ROOF NEEDS TO BE SEALED OFF

Recommendations for Future Repair Work ROOF, CEILINGS ON EAST SIDE OF HOUSE, ELECTRICAL, SOME WALL PANELS NEED REPLACING
